June 3, 2013

Electric Power Development Co., Ltd.

### Resumption of Operation of New No. 2 Unit at Isogo Thermal Power Plant

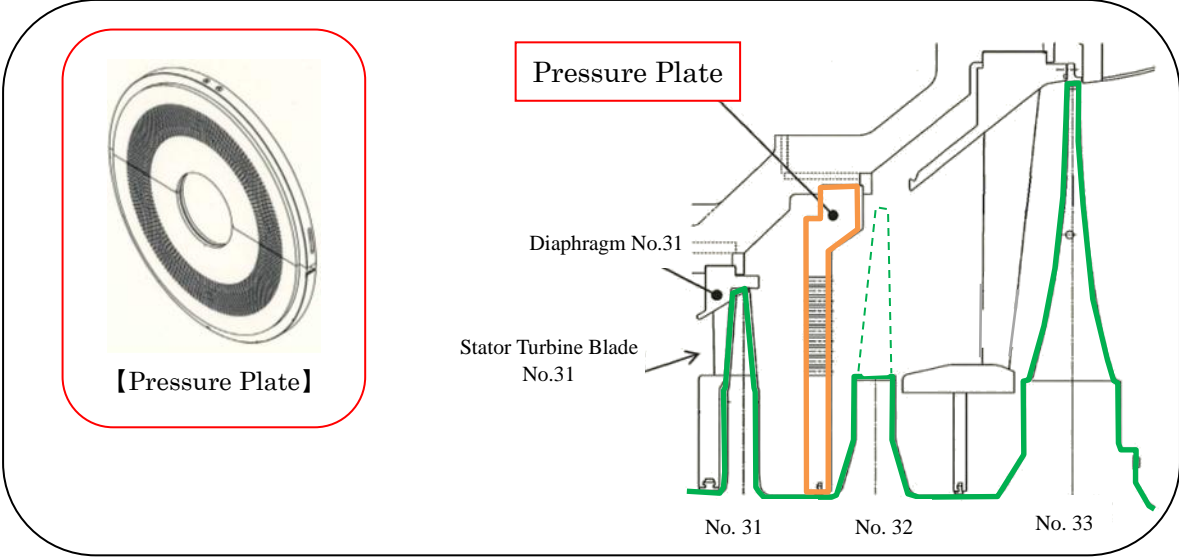
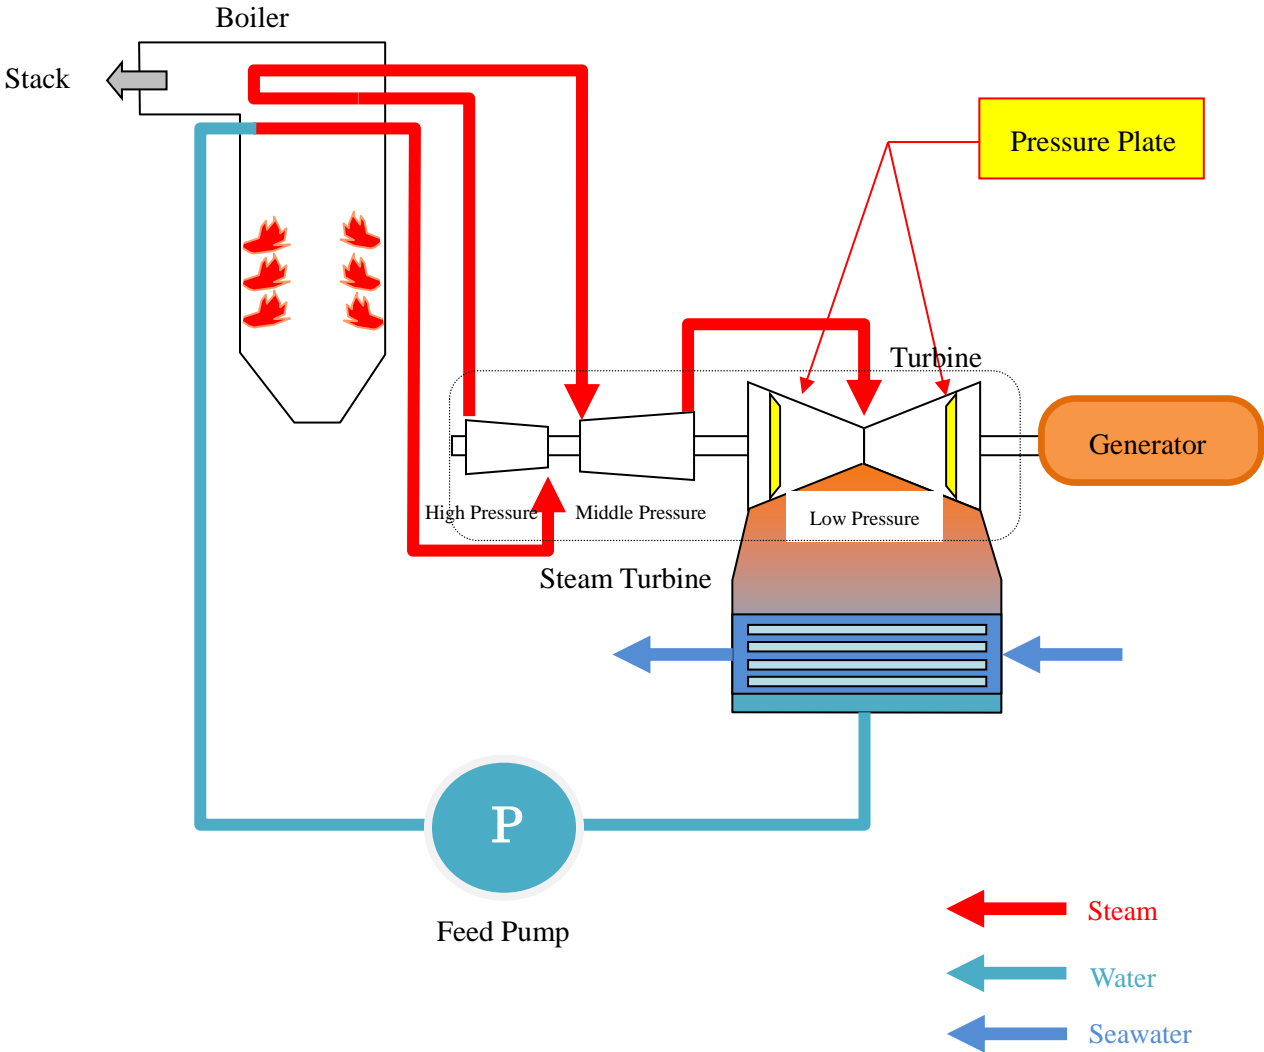
【Installation Location of Pressure Plate】

Currently, J-POWER is investigating the cause and examining measures, it is believed that permanent measures for this rotating blade will require a longer period. However, in the interest of early resumption, the damaged rotating blade (No.32) in the low-pressure turbine has been removed and a temporary measure was implemented by installing two pressure plates<sup>1</sup>, and commercial operations resumed at midnight on June 1.

1. Pressure Plate: Installed as an alternative to the removed turbine blade (No.32). By using a porous plate with a rectifying effect, reduces steam pressure to ensure differential pressure to the design pressure in the relevant location between No.31 blade and No.33 blade.
