December 27, 2012

Electric Power Development Co., Ltd.

Status of New No. 2 Unit Turbine Inspection at Isogo Thermal Power Plant

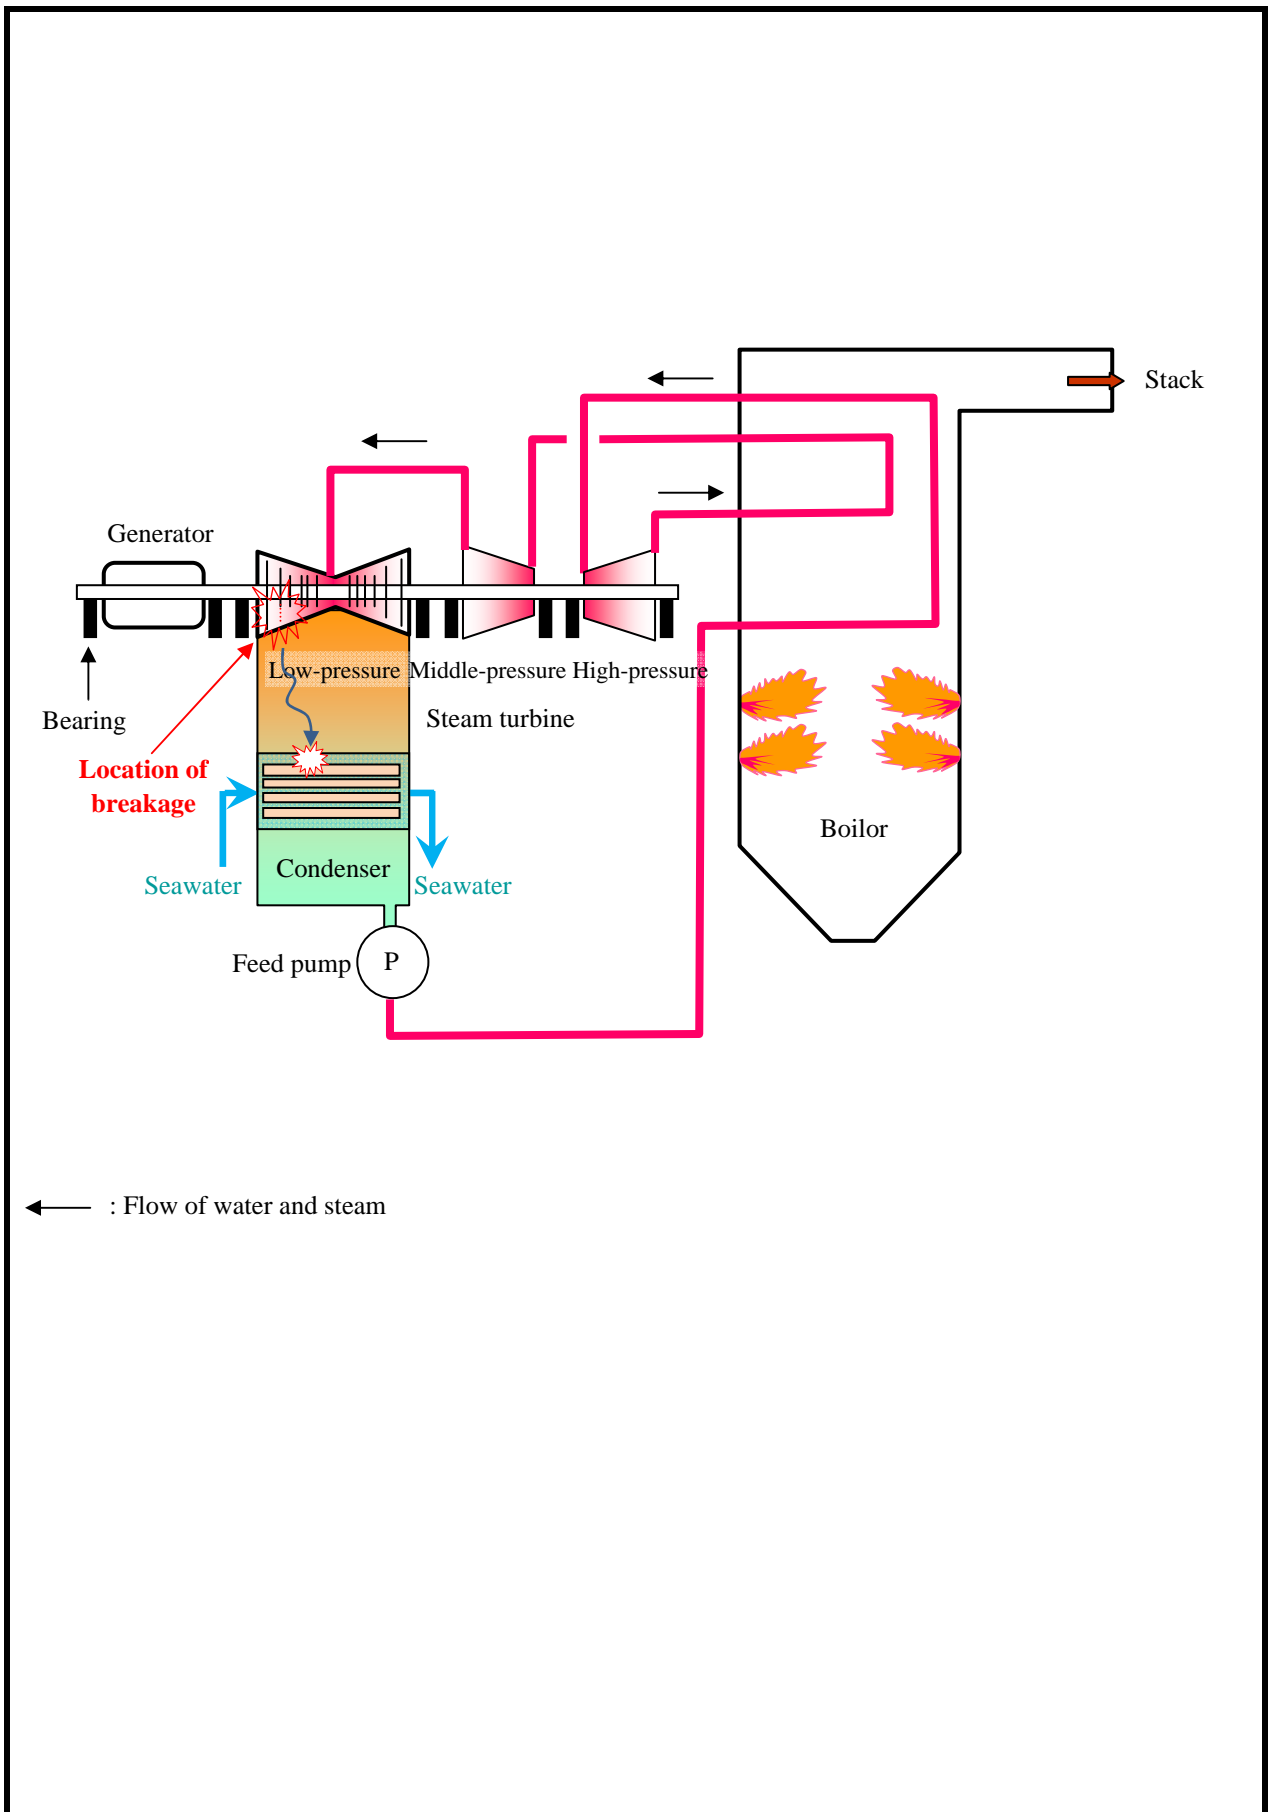
Location of Damage to the Turbine and Condenser

Subsequently, the turbine was dismantled and inspected, and other relevant equipment examined, upon which it was found that the malfunction was due to breakage of a rotating blade in a low-pressure turbine. It was also found that the broken rotating blade then caused damage to other rotating blades in the low-pressure turbine; fragments of the turbine blades then caused cracks in the interior of the condenser*, which allowed an influx of seawater into the pipes, etc.

Currently, J-POWER is investigating the cause of the breakage of the turbine rotating blade, while also working to repair the low-pressure turbine and clean any pipes, etc. through which seawater may have flowed. Going forward, J-POWER will work to ensure the quickest possible restoration of operations, but because time will be needed to manufacture replacements for the damaged rotating blades in the low-pressure turbine, at this point operations are expected to resume sometime in the latter half of May, 2013.
